A Filthy USV Survey – With AKS Engineering & Forestry

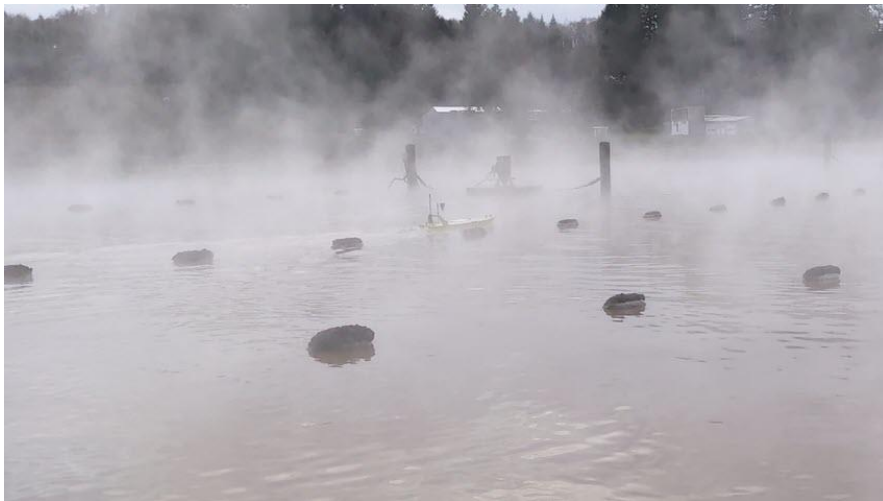
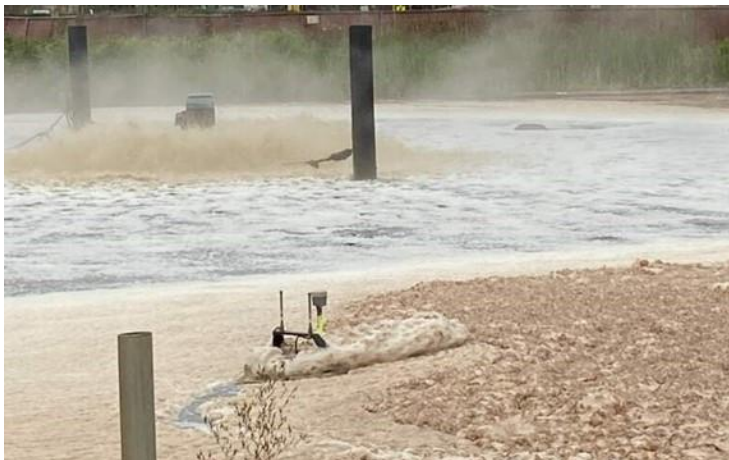
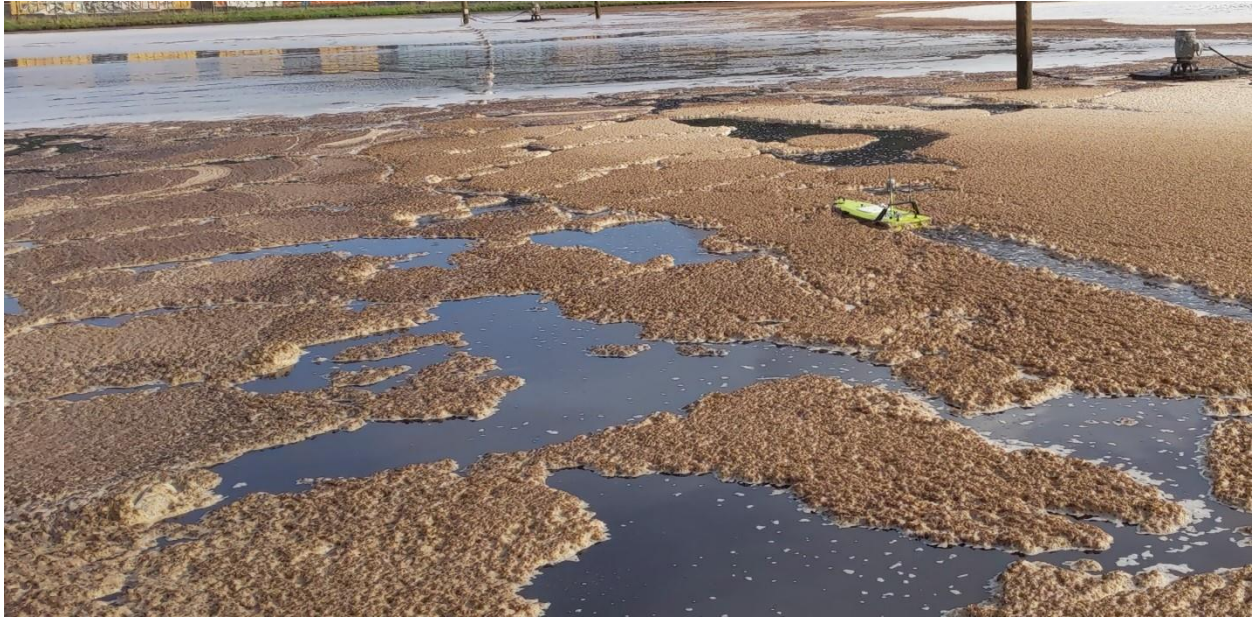
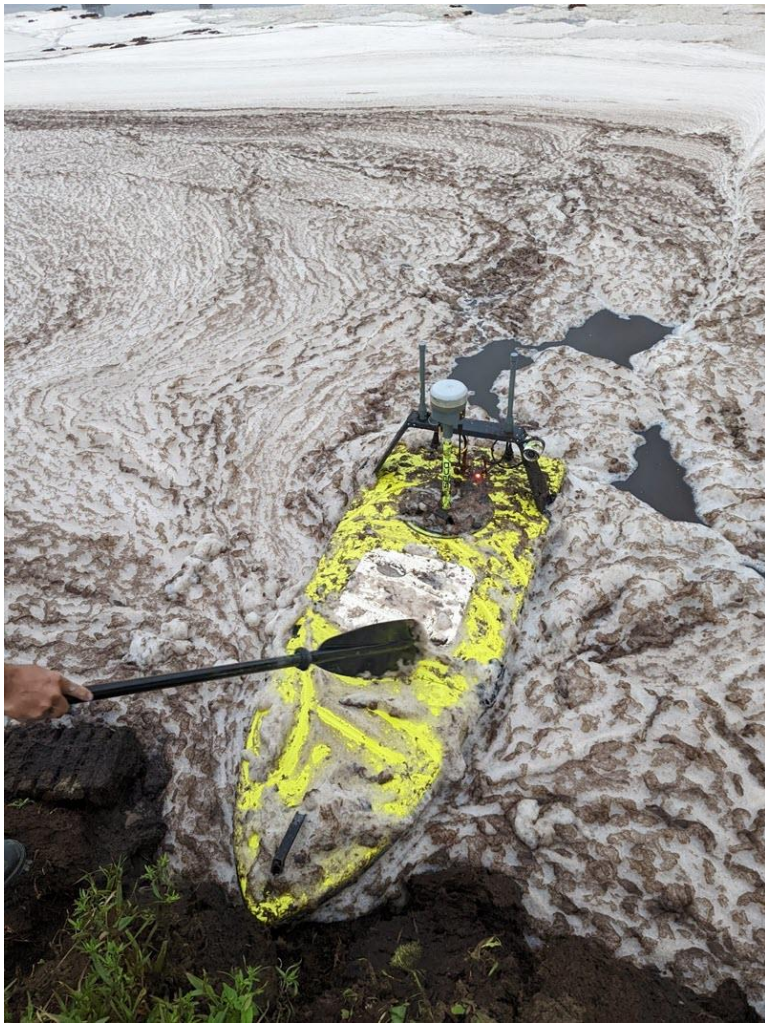
Choosing the USV proved to be a sensible decision! The surveyors encountered a variety of undesirable environments in each pond, including the objectionable aroma of wastewater being aerated and treated, significant amounts of surface foam generated by the aerators, steam from warm wastewater obscuring visibility, and residual sludge that required manual scrubbing to remove from the vessel hull. The photographs below illustrate some examples of the less-than-ideal survey environment.

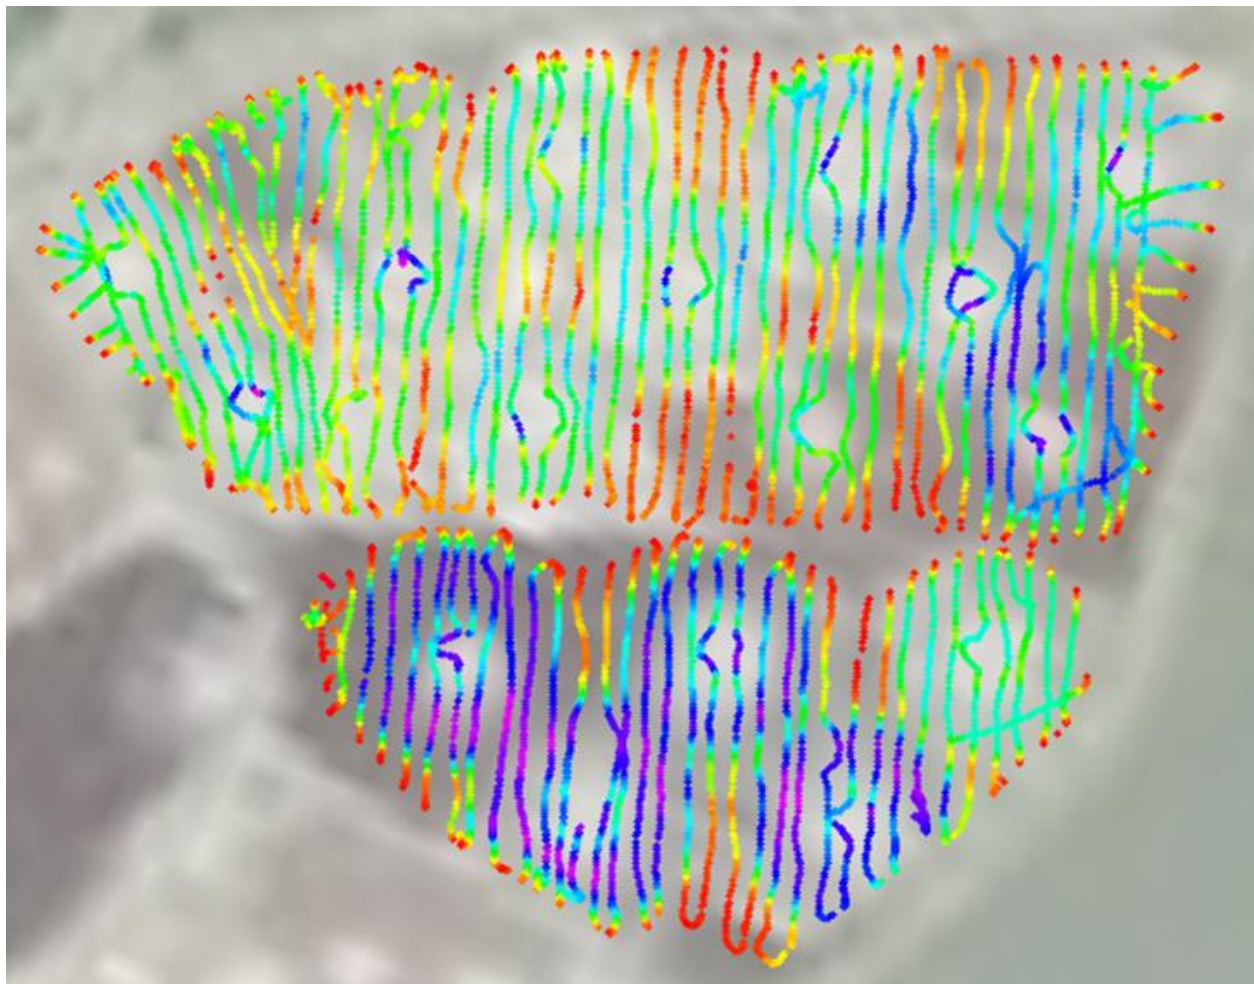
The screenshot below illustrates example survey results from a few of the ponds. Water depths ranged from approximately 0 feet (red) to 15 feet (purple). As would be expected, deeper water depths are observed in proximity to aerators, where sediment is mobilized, while shallower areas are located further away from the active aeration process.

It was not possible to survey autonomously with the USV. The presence of water aerators, numerous floating buoy lines, and other surface obstacles required an operator to control the USV at all times. The targeted line spacing was 25 feet. In total, the linear survey distance within all ponds was approximately 14 miles, comprising 200 lines, that required two days to complete.
